DRAFT-FINAL GENERAL MILLS/HENKEL CORP SUPERFUND SITE MINNEAPOLIS, MINNESOTA

FIVE-YEAR REVIEW REPORT

September 2014

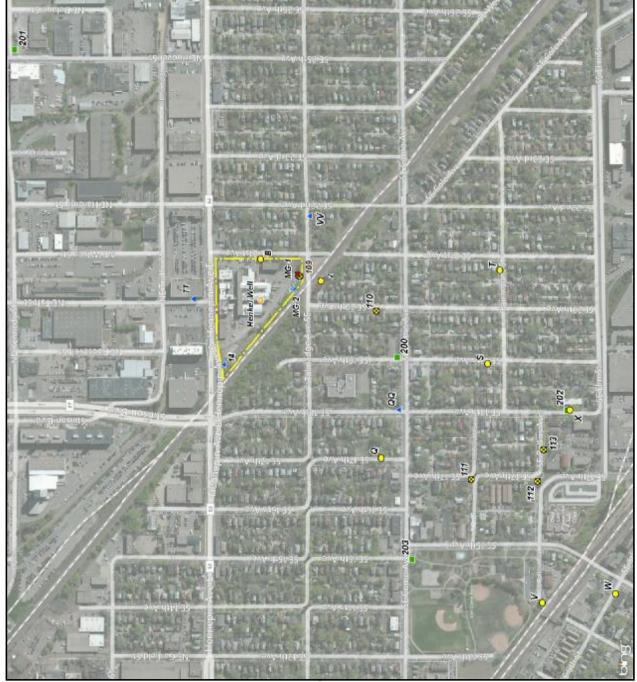
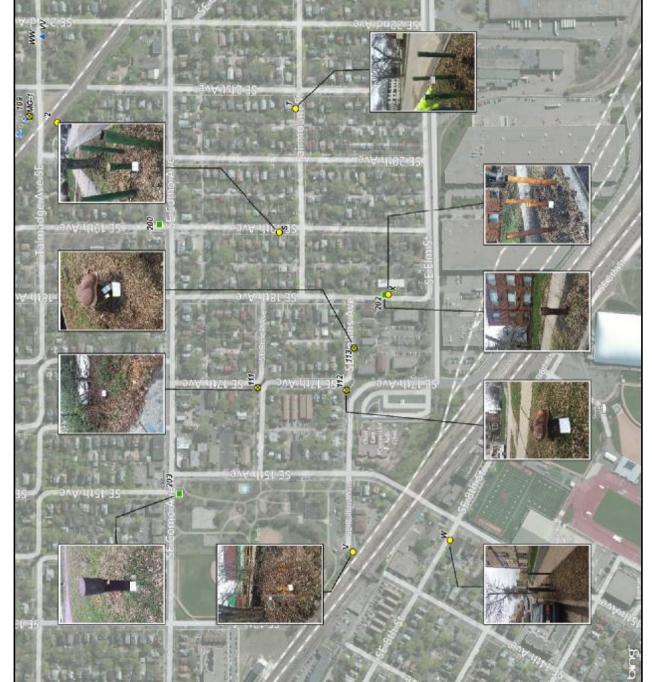
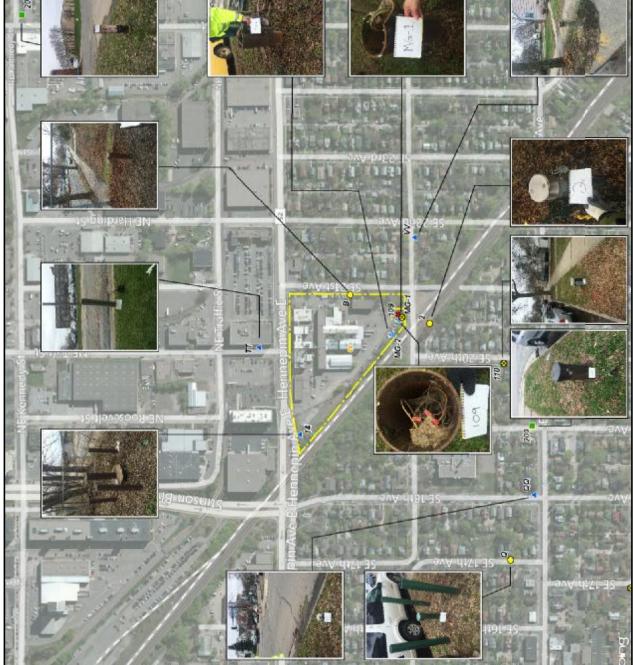
Figure 1 2014 Five Year Review Monitoring Well Locations General Mills 2010 E Hennepin Avenue, Minneapolis Ninneapolis Ninneapolis

- All existing pump-out and monitoring wells were located (Figure 1) and inspected. Representative photographs were taken of each well and are included on Figures 2 and 3. A well inventory sheet listing all existing wells is included in Appendix E. As noted in the well inventory form, several wells require maintenance. These wells are only inspected during the groundwater monitoring event (currently every five years). Annual well inspection and repair, as necessary, is recommended.

Several monitoring and pump-out wells appear to require more frequent maintenance. These wells are only inspected during the groundwater monitoring events (currently every five years). Consequently, annual well inspection and repair, as necessary, is recommended.

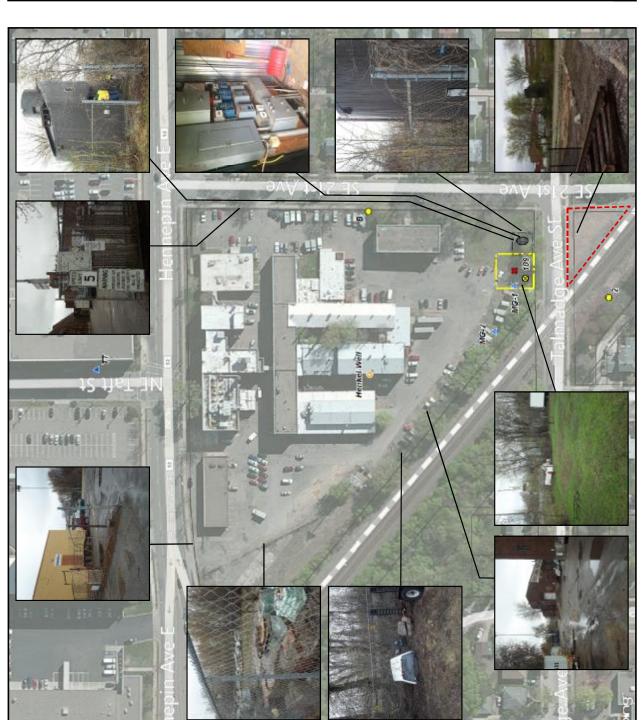
As noted in the well inventory form (**Appendix F**), several monitoring and pump-out wells require maintenance. These wells are only inspected during the groundwater monitoring event (currently every five years).

Annual well inspection and repair, as necessary, is recommended. Although periodic monitoring, inspection and repair of the pump-out and treatment systems are being conducted (currently proposed for every five years), in the event that the pump-out and treatment systems are taken out of idled status, it is recommended that the entire system be thoroughly inspected and repaired with upgrades as necessary.

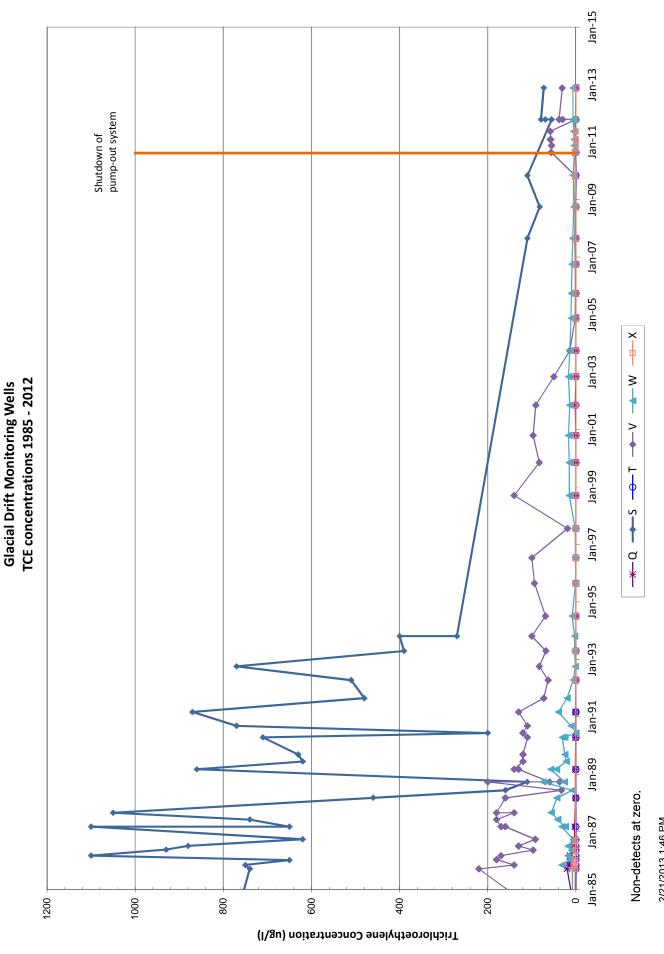
<u>Glacial Drift Wells.</u> TCE concentrations in the samples from the glacial drift wells during the groundwater monitoring event were below the TCE limit (270 μ g/L) set forth in the Consent Order. Temporal trends in TCE concentrations in groundwater at the glacial drift wells **Appendix B** (labeled Figure 13 and 14) during the shutdown period are as follows:

GLACIAL DRIFT GROUNDWATER QUALITY (TCE) - 2012 East Hennepin Avenue Site Minneapolis, Minnesota

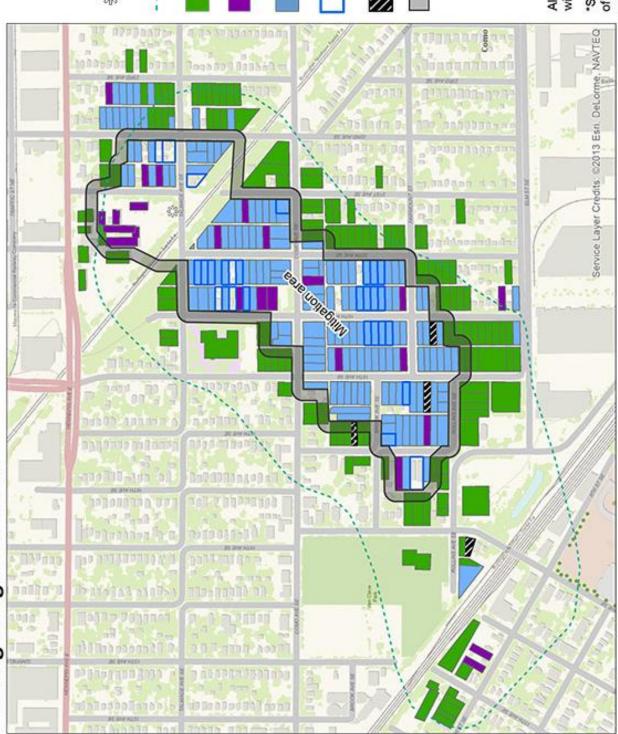
Soil Vapor: SE Hennepin Ave - Minneapolis **Building Mitigation Status**

but is not required based Mitigation will be offered

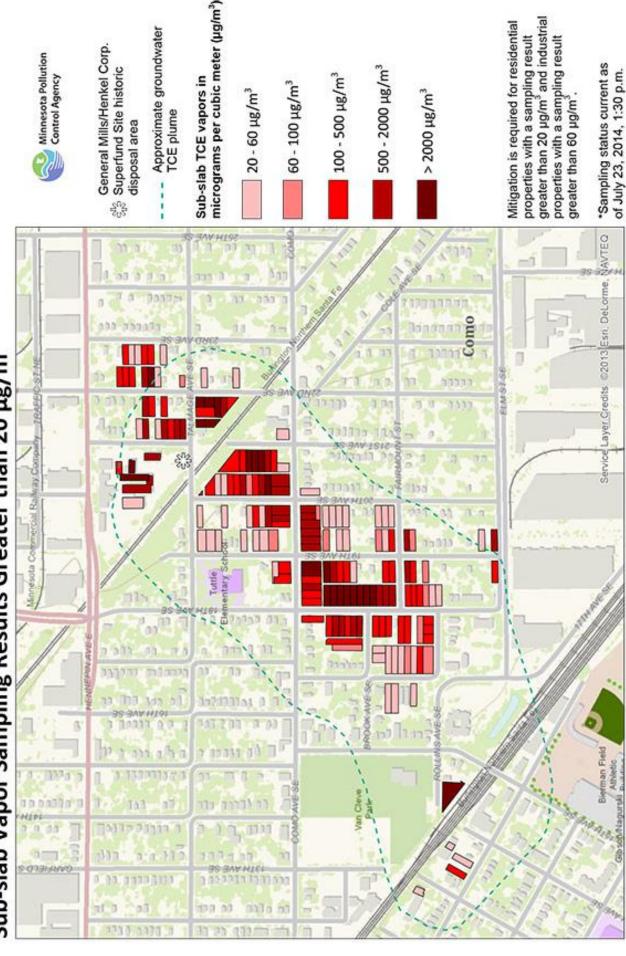
Soil Vapor: SE Hennepin Ave - Minneapolis Sub-slab Vapor Sampling Results Greater than 20 μg/m³

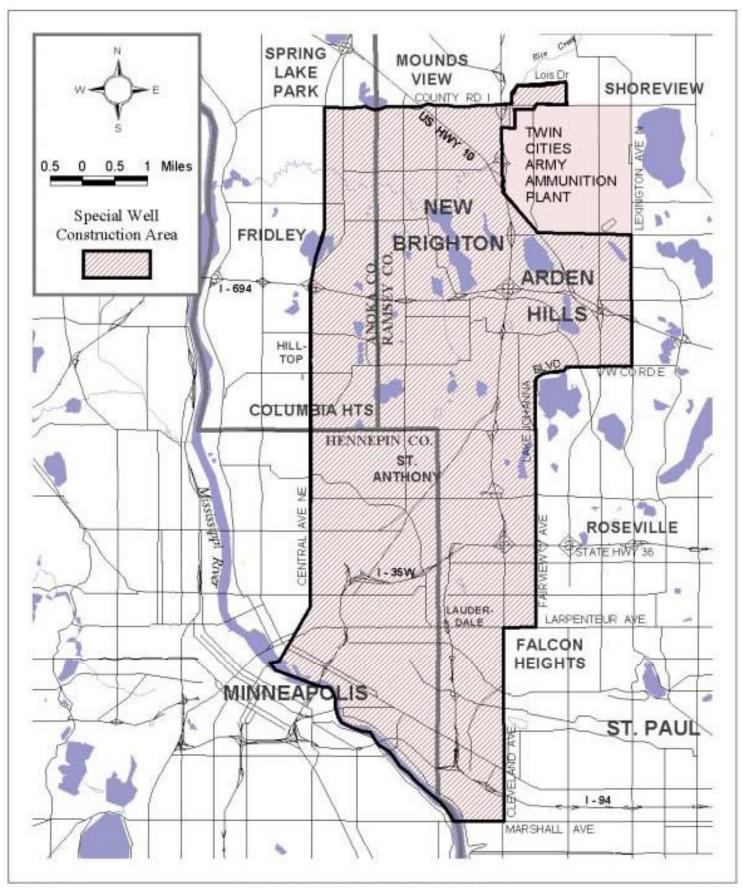
Special Well Constructon Area Twin Cities Army Ammunition Plant
